# Pest & Building Report

**Charles & Anne Bradbury**

**1092 Towrang Road Towrang**

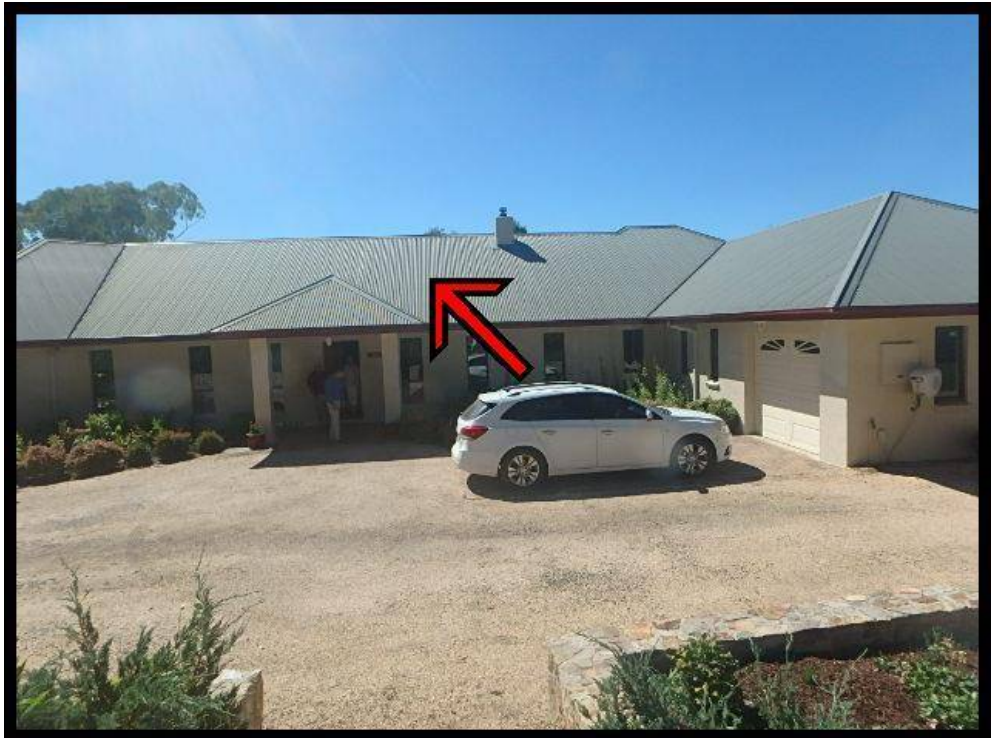
The overall condition of the roof coverings is good.

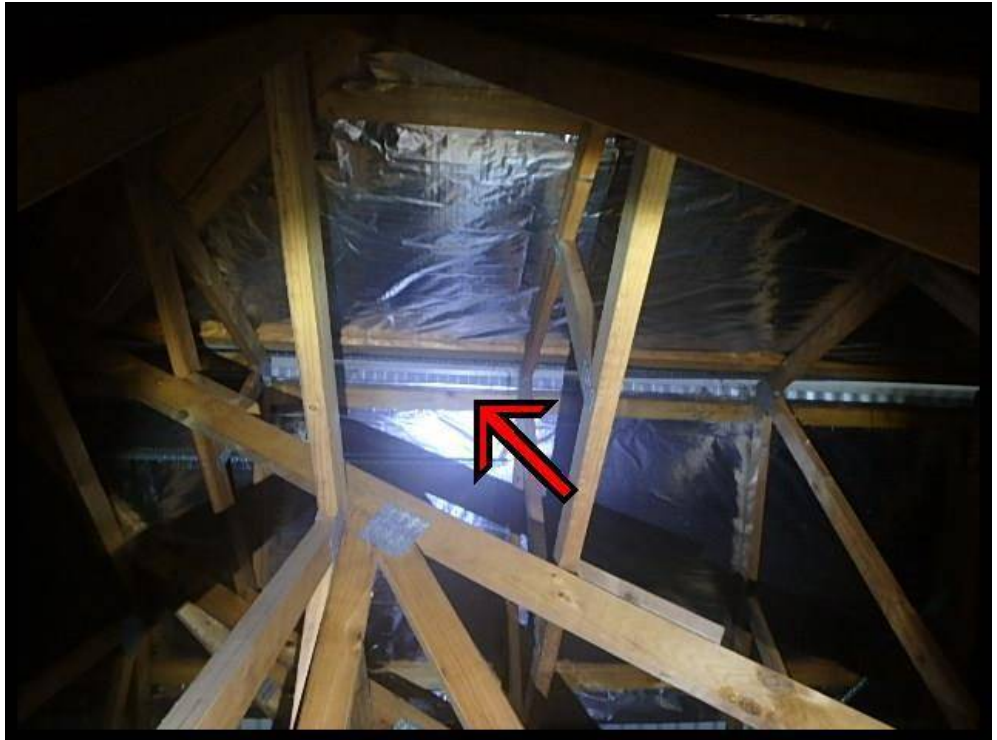
Inspection over the eaves was restricted due to the low pitch and construction allowing only a limited visual inspection from a distance to be carried out.

Insulation is present in the roof cavity. This restricted inspection to some roofing timbers. Removal of insulation is not within the scope of a standard visual timber pest inspection report however, this would be necessary for a more complete report to be submitted.

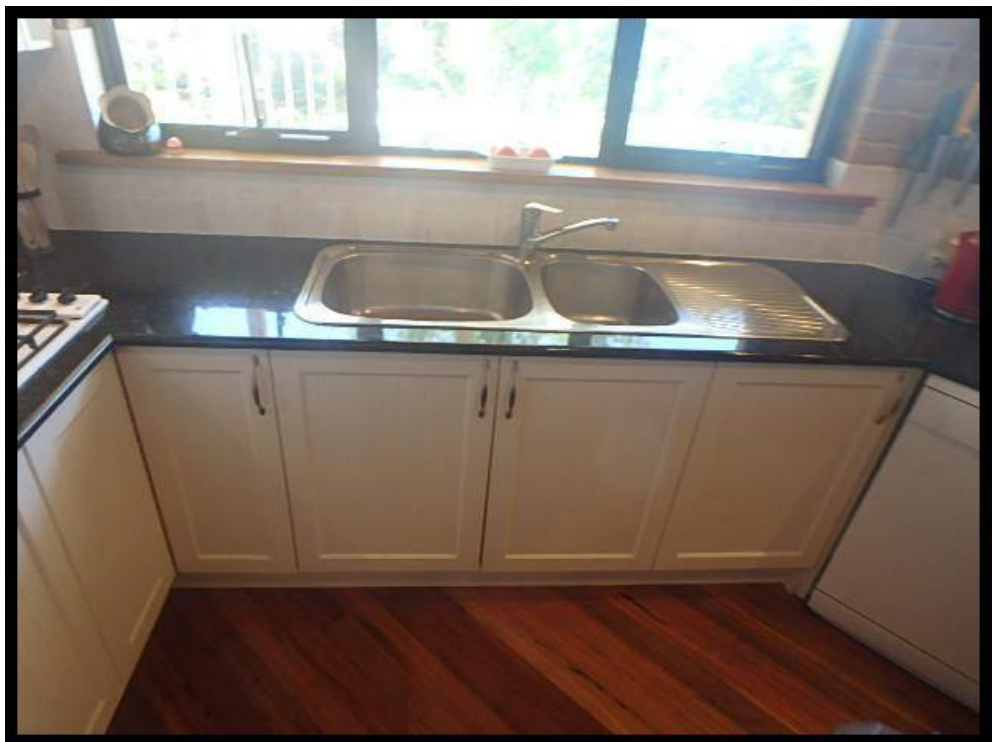
The condition of the fixtures is generally good. Wear and tear is noted to cabinets and/or doors and some maintenance or repairs will be required.

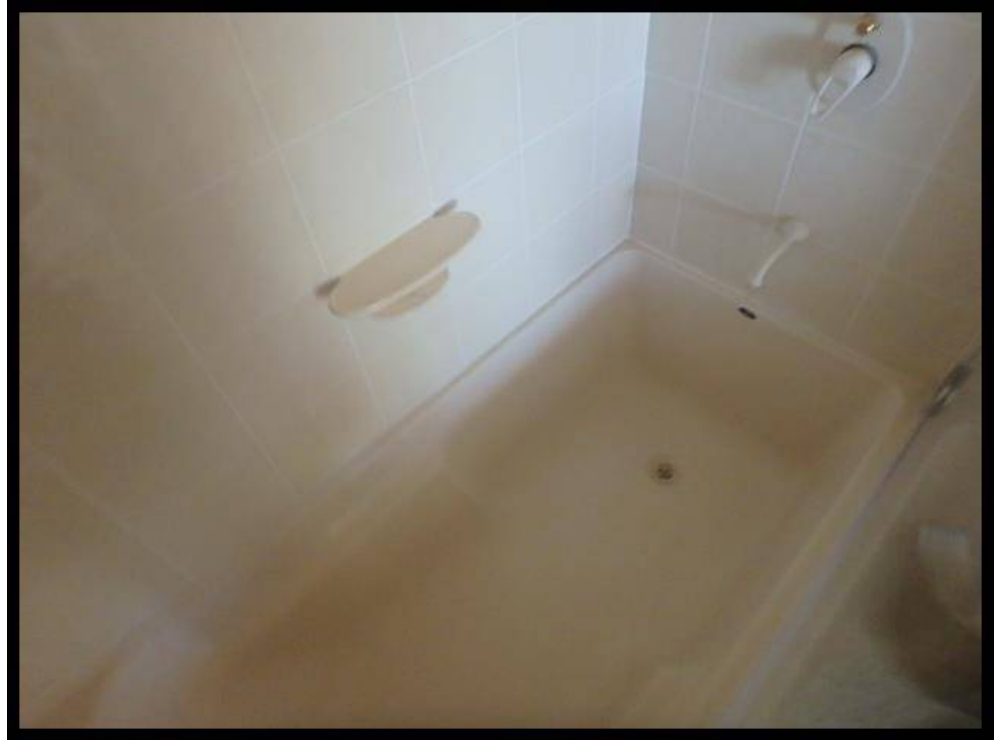
The shower is located over the bathtub. The area will need to be kept well sealed to prevent water penetration to surrounding areas.

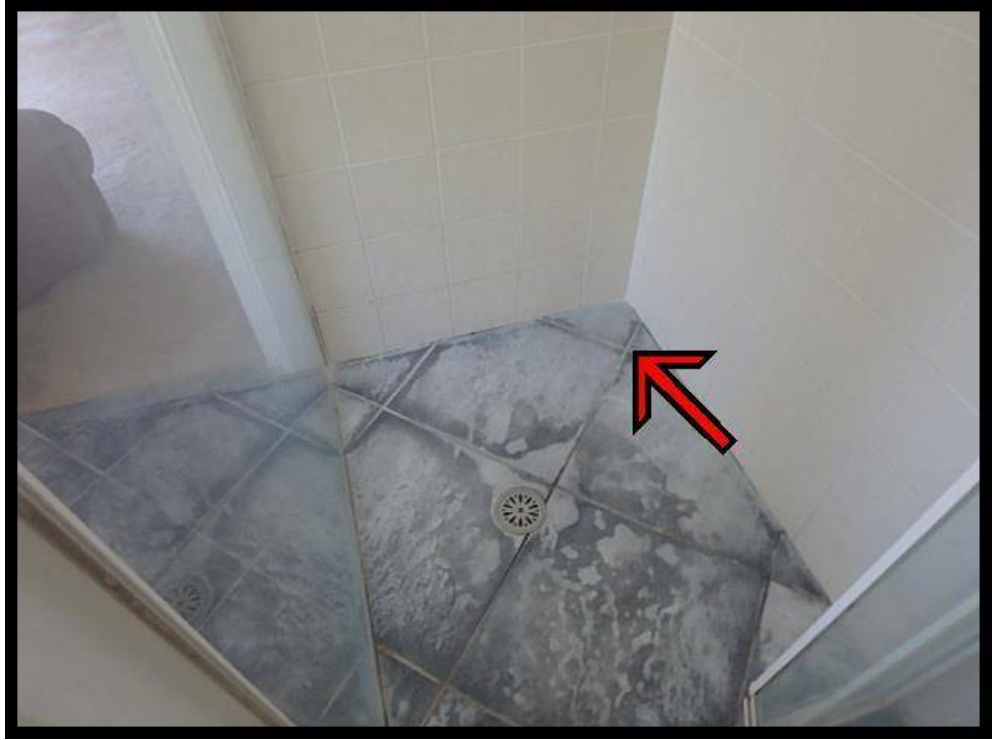
The shower recess was tested and there was no visible water penetration to surrounding areas. The waterproofing on the shower is out of warranty and we recommend the purchaser contact a shower waterproofing company to advise on further waterproofing & extended warranty options. **IMPORTANT NOTE:** This test may not reveal water leaks until the shower is put into constant use and surrounding areas monitored over a period of time.

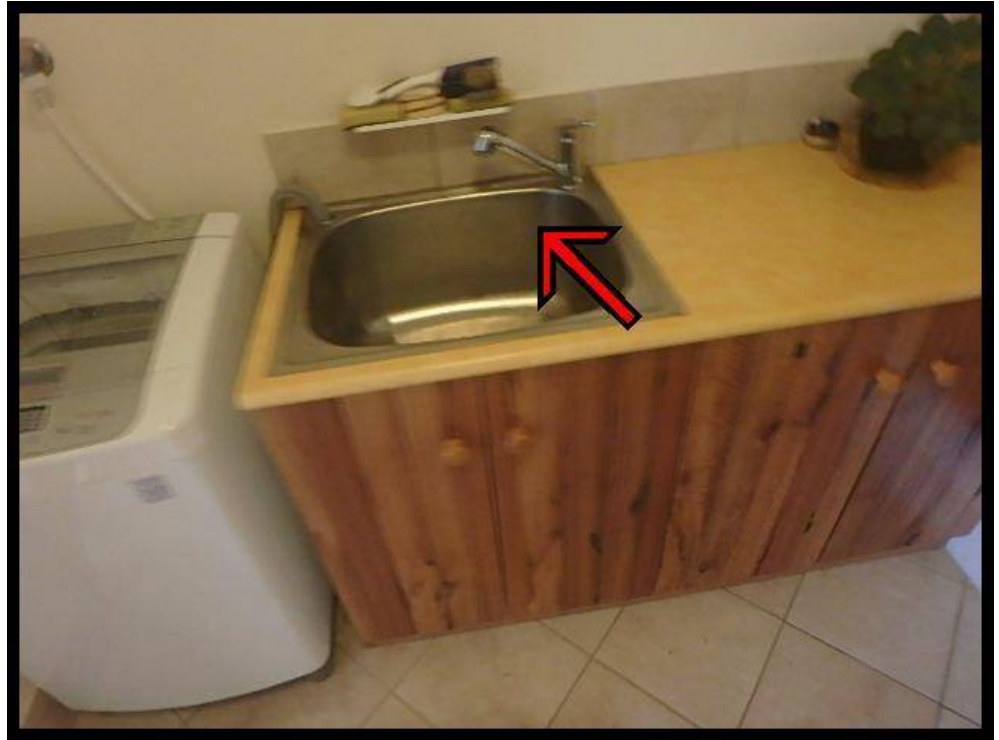
The tub and taps appear serviceable.

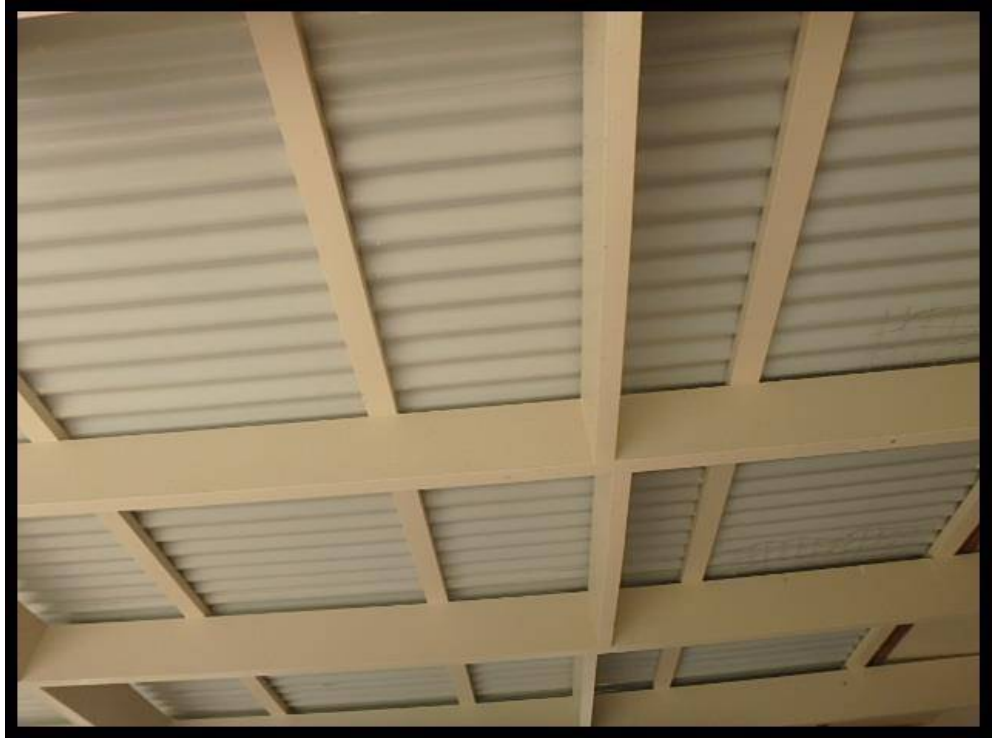
**Position/Location:** Rear elevation.

Constructed from timber. The general condition of this structure is good.

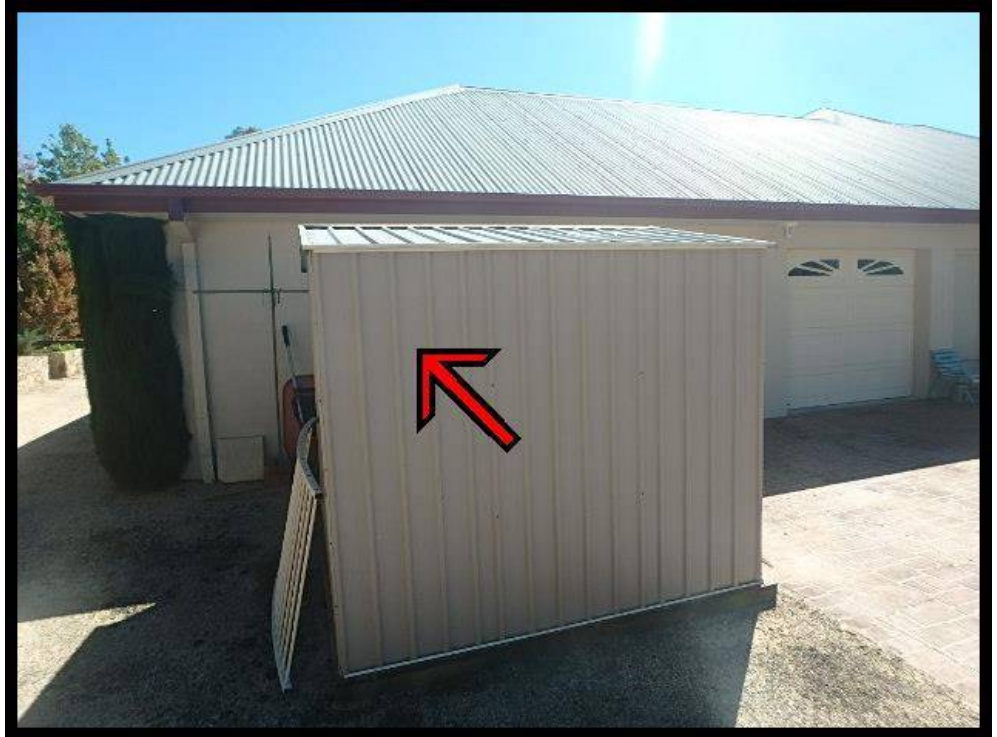
Metal garden shed:

The structure is generally in good condition.

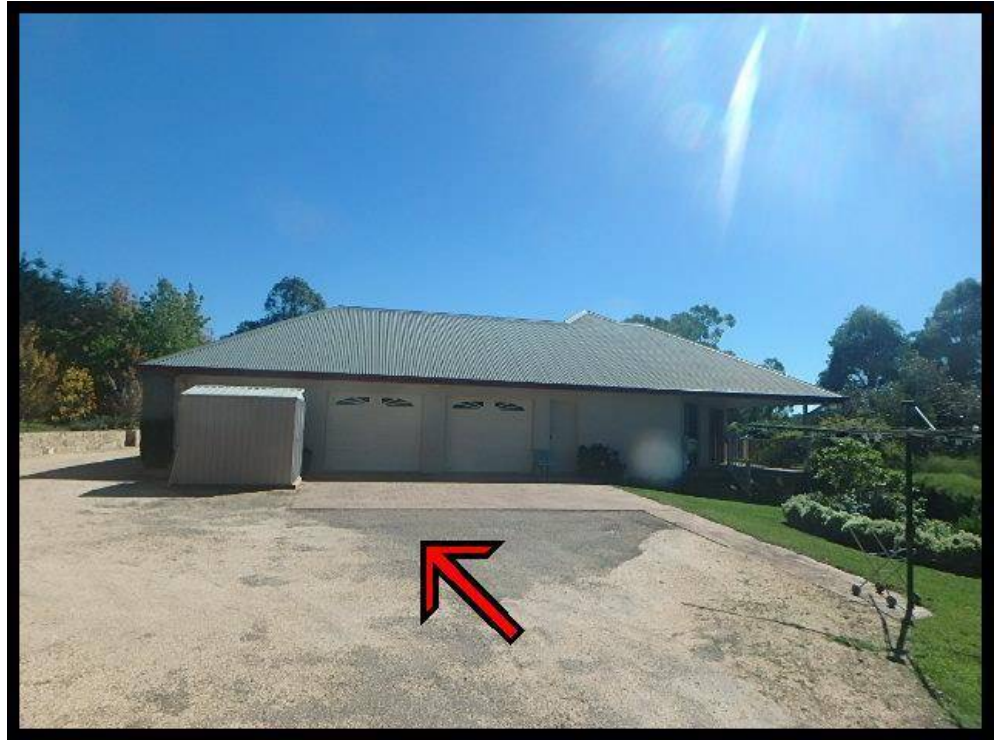
The gravel driveway stands in fair condition.

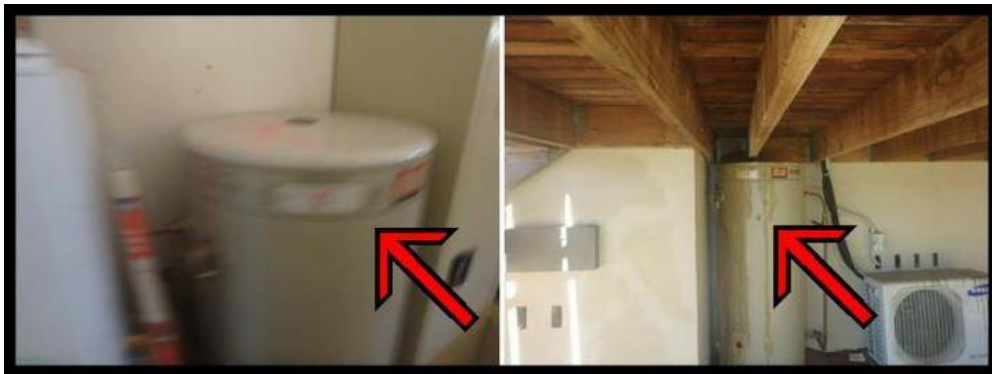
Mains electric hot water system: Mains pressure: The hot water system appears to be in working condition. No specific tests other than running the hot water from a tap was carried out. No determination has been made as to the suitability or adequacy of the hot water system in relation to capacity or otherwise.
